# **INDOOR AIR QUALITY ASSESSMENT**

**James F. Peebles Elementary School Annex  
70 Trowbridge Road  
Bourne, Massachusetts**

Prepared by:  
Massachusetts Department of Public Health  
Center for Environmental Health  
Bureau of Environmental Health Assessment  
Emergency Response/Indoor Air Quality Program  
June 2004

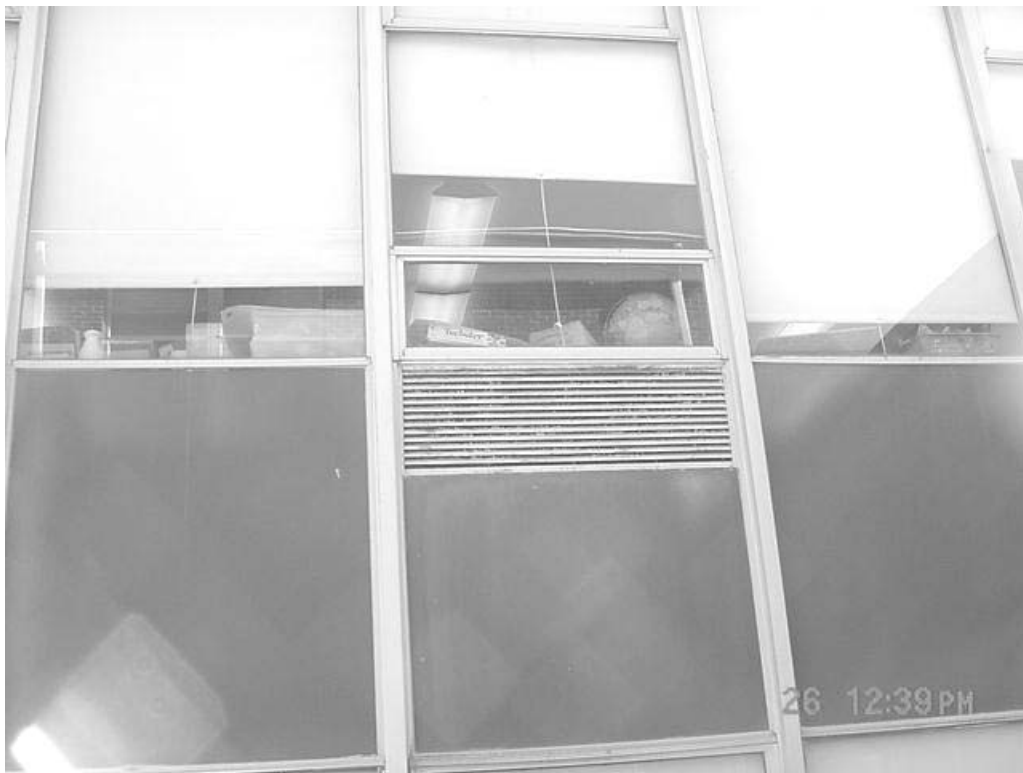
**Picture 1**

Fresh air in classrooms is supplied by a unit ventilator (univent) system. Univents are designed to draw air from outdoors through a fresh air intake located on the exterior walls of the building (Picture 1) and return air through an air intake located at the base of each unit ([Figure 1](#)). Fresh and return air are mixed, filtered, heated and provided to classrooms through a fresh air diffuser located in the top of the unit. Univents were reported to be original equipment (approximately 50 years old), which can make them difficult to maintain/function due to unavailability of parts. The univent in classroom 21 was operating on “high”; however, the unit appeared to be operating at low capacity. Obstructions to airflow, such as papers and books

**Univent Fresh Air Intake**

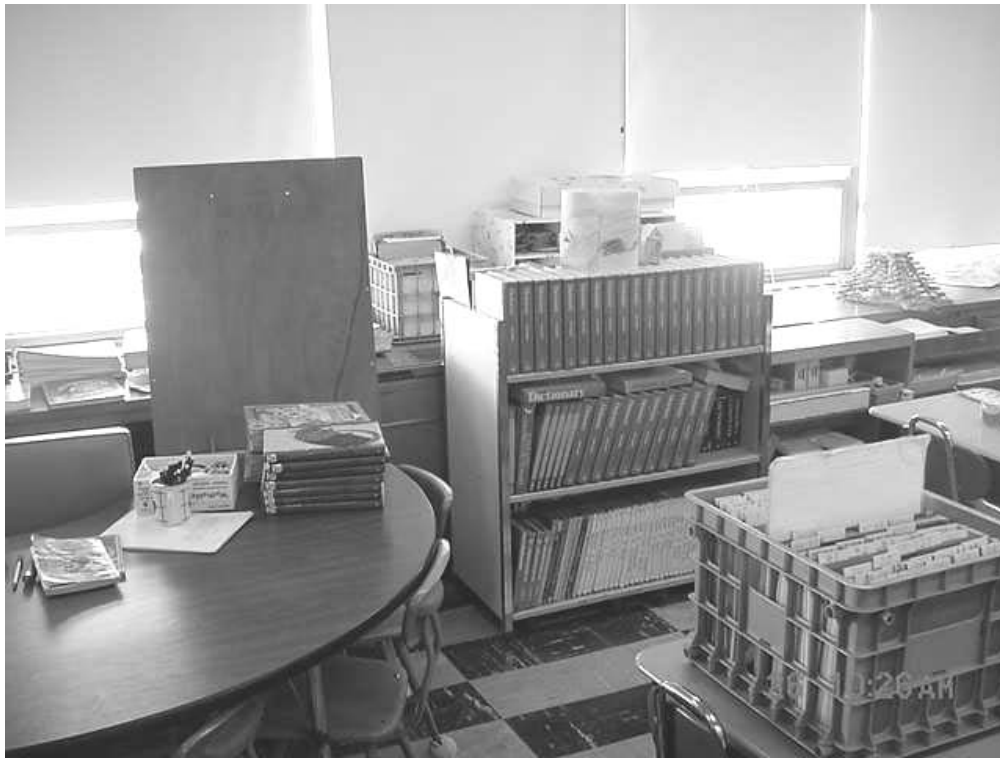
**Picture 2**

stored on univents and bookcases, carts and desks in front of univent returns, were also seen (Picture 2). In order for univents to provide fresh air as designed, intakes must remain free of obstructions.

**Classroom Univent Obstructed by Various Items**

3. Remove all blockages from univents and exhaust vents to ensure adequate airflow.
4. Consider balancing mechanical ventilation systems every 5 years, as recommended by ventilation industrial standards (SMACNA, 1994).

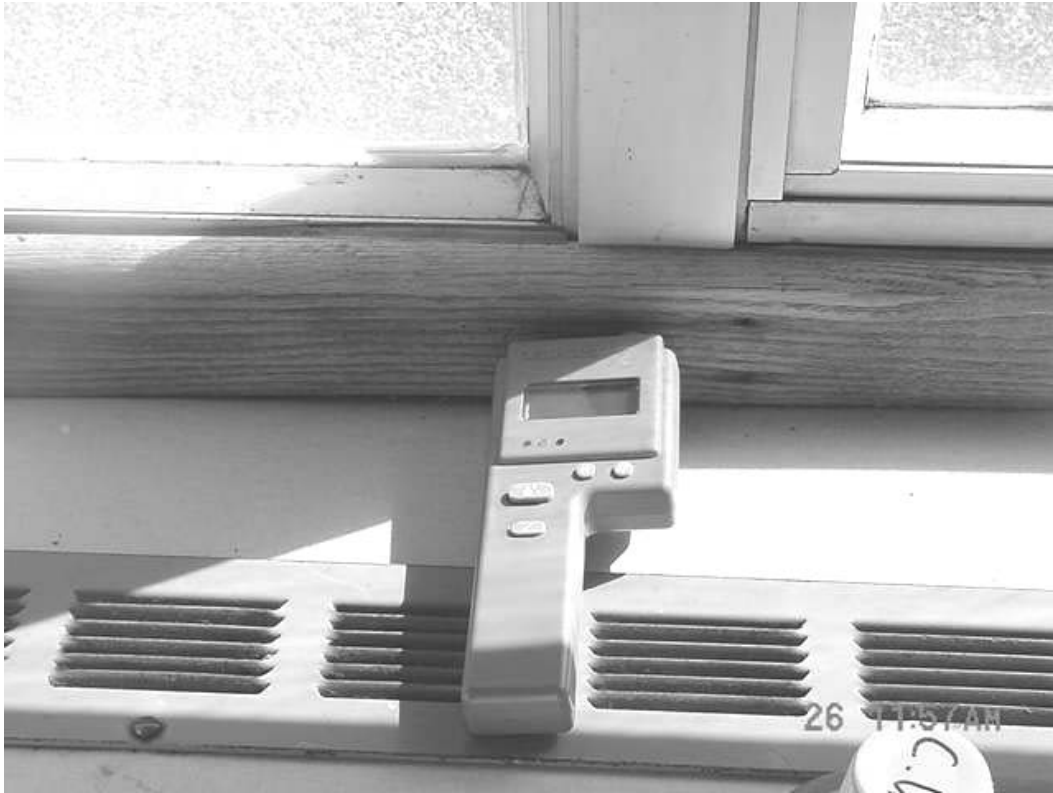
**Picture 3**

Water damaged building materials beneath the ruptured heating coil did not have elevated moisture levels, indicating they had dried. Elevated moisture measurements were recorded in wooden windowsills in classroom 17 (Table 1/Picture 3), an area not affected by the ruptured heating coil. This measurement would indicate that the moisture dampening the windowsills could either be from high ambient relative humidity conditions or from moisture penetrating through the window system. It is important to note that moisture content of the annex building components was measured in real-time and is indicative of conditions present in the building at the time of the assessment. The building was evaluated on a sunny day, with an outdoor temperature of 56° F and relative humidity of 20 percent. Prior to the assessment, the last measurable rain in the Bourne area was February 21, 2004, five days prior to the assessment date of February 26, 2004 (The Weather Underground, 2004). This means that classroom windowsills remained moist for an extended period of time. Moisture content may increase or

decrease depending on building and weather conditions. For example, during the normal operation of a heating, ventilating and air-conditioning (HVAC) system, moisture is introduced into a building under conditions with high relative humidity. As indoor relative humidity levels increase, porous building materials can absorb moisture. Due to the low relative humidity measured indoors during the assessment, it is unlikely that the windowsills in classroom 17 were moistened from excessive ambient relative humidity.

**Elevated Moisture Content of Wooden Window Sill in Classroom 17**

6. Seal window frames to prevent water penetration and further water damage.  
Replacement of chronically damaged wooden windowsills should be considered.

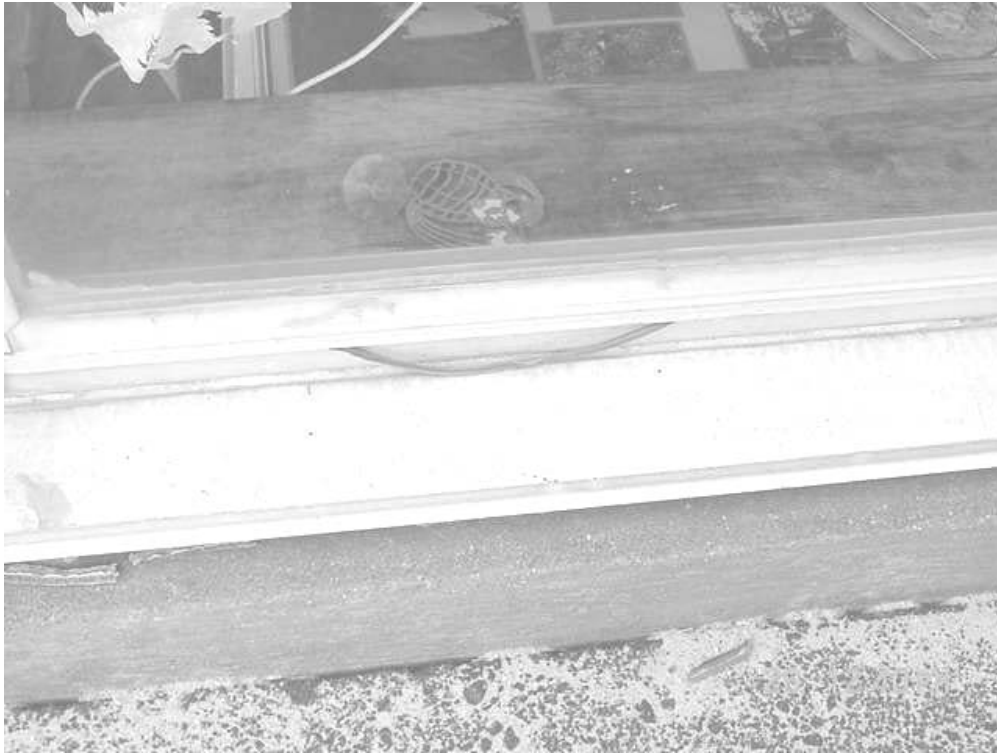
**Picture 4**

Caulking around windows was missing/damaged in many areas (Picture 4). Water damaged wooden window frames and leaks were observed in several classrooms. Missing caulking and/or loose fitting window panes can make it difficult to control temperature and provide a means for water penetration into the building, leading to comfort complaints and/or water damage and subsequent microbial growth. Like other porous materials, wood that is wetted repeatedly can provide a medium for mold growth. Mold and related particulates can be irritating to sensitive individuals. In order for building materials to support mold growth, a source of moisture is necessary. Identification and elimination of water moistening building materials is necessary to control mold growth.

**Missing/Damaged Window Caulking**

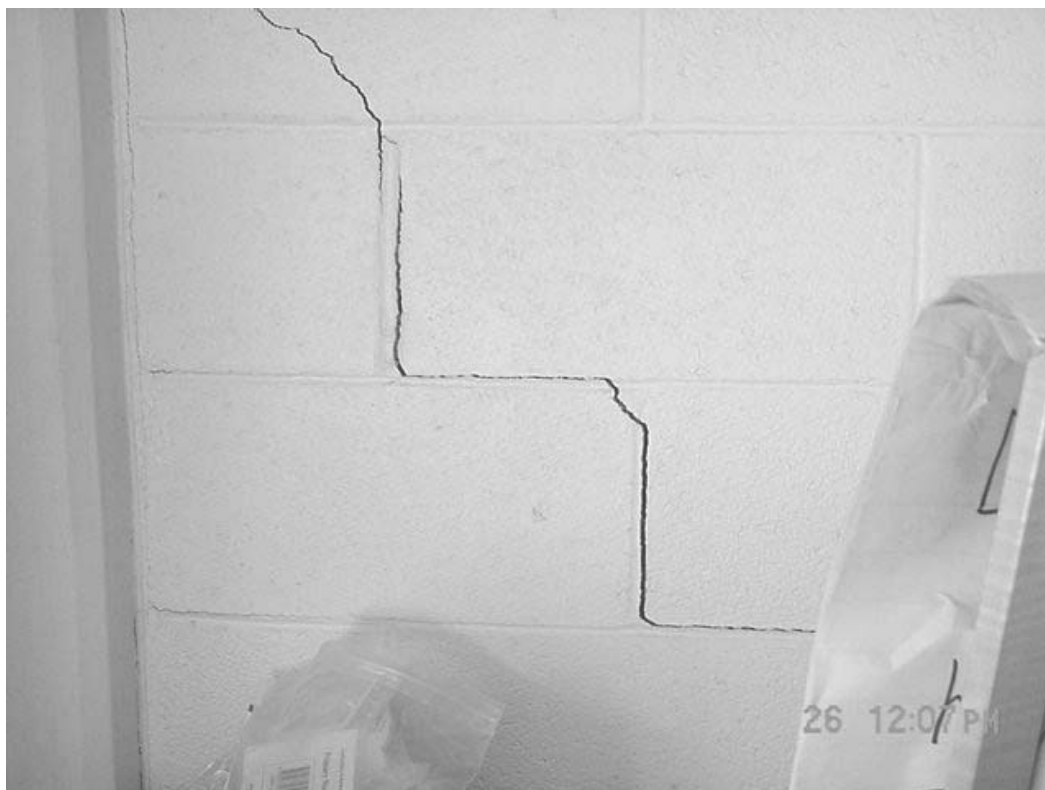
**Picture 5**

Interior and exterior wall cracks were observed (Pictures 5 and 6). Breaches in the building envelope can also provide a means for water penetration into the building. The US Environmental Protection Agency (US EPA) and the American Conference of Governmental Industrial Hygienists (ACGIH) recommends that porous materials be dried with fans and heating within 24-48 hours of becoming wet (US EPA, 2001; ACGIH, 1989). If porous materials are not dried within this time frame, mold growth may occur. Water-damaged porous materials cannot be adequately cleaned to remove mold growth. The application of a mildewcide to moldy porous materials is not recommended.

**Interior Wall Crack**

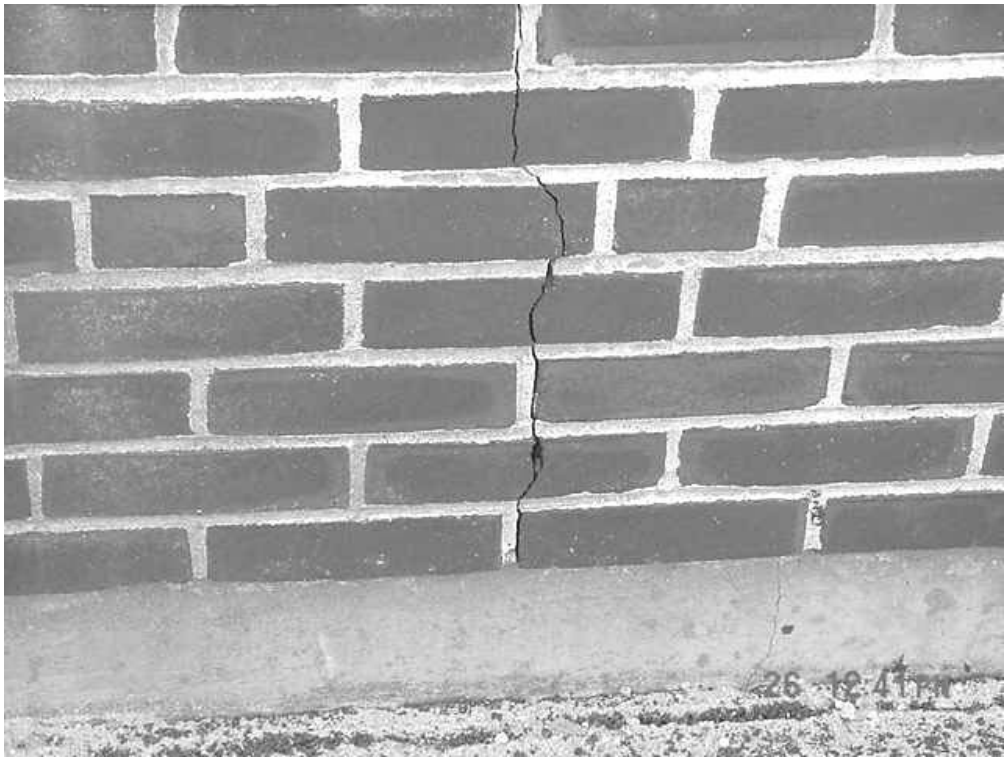
**Picture 6**

**Exterior Wall Crack**

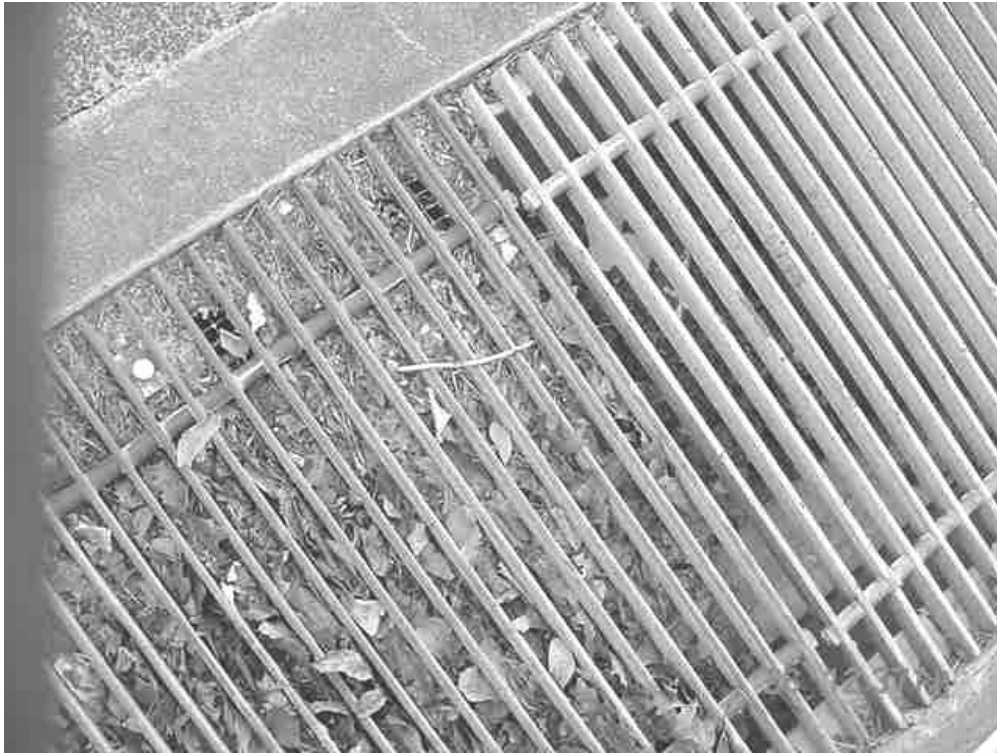
**Picture 7**

Several subterranean pits were located along the perimeter of the building. These pits allow airflow into below grade air intakes for the mechanical ventilation system. Leaves, papers and other debris were observed on grating and the floor of the pits (Picture 7), which can also provide a source of mold growth. Mold odors and growth can subsequently be entrained into the ventilation system.

**Leaves and Debris in Subterranean Air Intake Pit**

8. Remove leaves and debris from subterranean pits seasonally.
9. Move plants away from univents in classrooms. Avoid over-watering and examine drip pans periodically for mold growth. Disinfect with an appropriate antimicrobial where necessary.

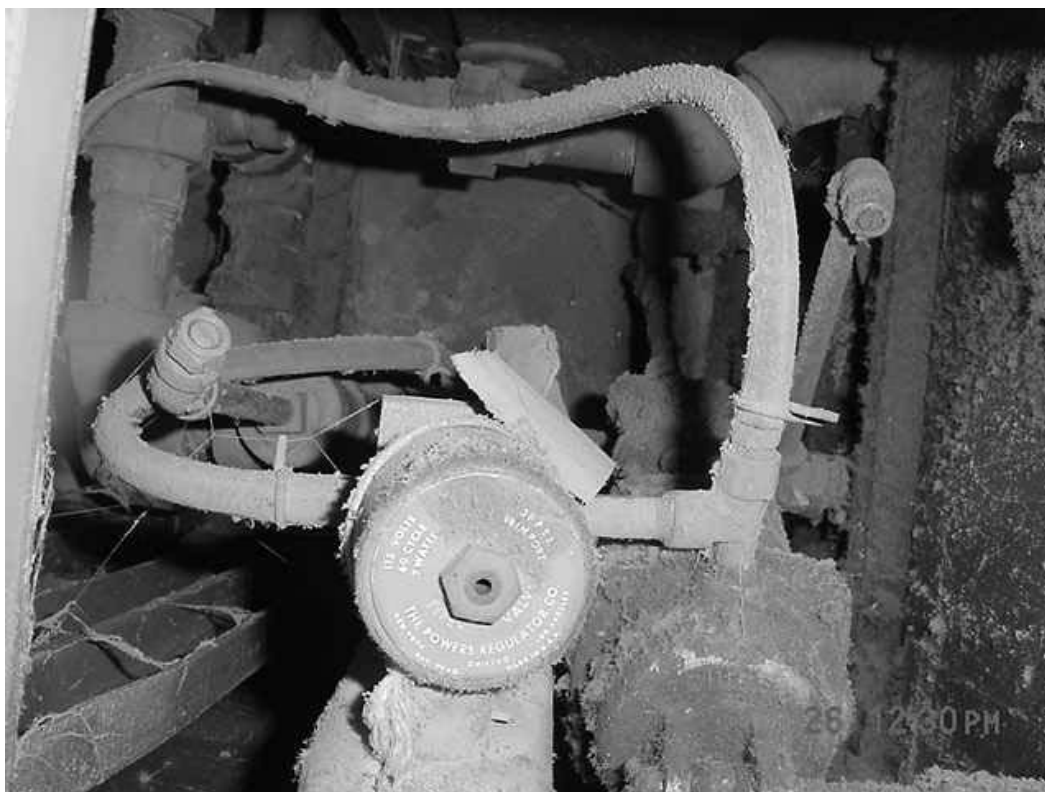
**Picture 8**

Several other conditions were noted during the assessment that can affect indoor air quality. A number of units had accumulated dust, cobwebs and debris within the air handling chambers (Picture 8). Exhaust vents in coat closets were also coated with accumulated dust (Picture 9). In order to avoid this equipment serving as a source of aerosolized particulates, the surfaces of exhaust vents and the air handling sections of the units should be regularly cleaned (e.g., during regular filter changes). Dust can be irritating to eyes, nose and respiratory tract.

**Accumulated Dust in Univent Interior**

10. Change filters for air-handling equipment as per the manufacturer's instructions or more frequently if needed. Vacuum interior of units prior to activation to prevent the aerosolization of dirt, dust and particulates. Ensure filters fit flush in their racks with no spaces in between allowing bypass of unfiltered air into the unit.

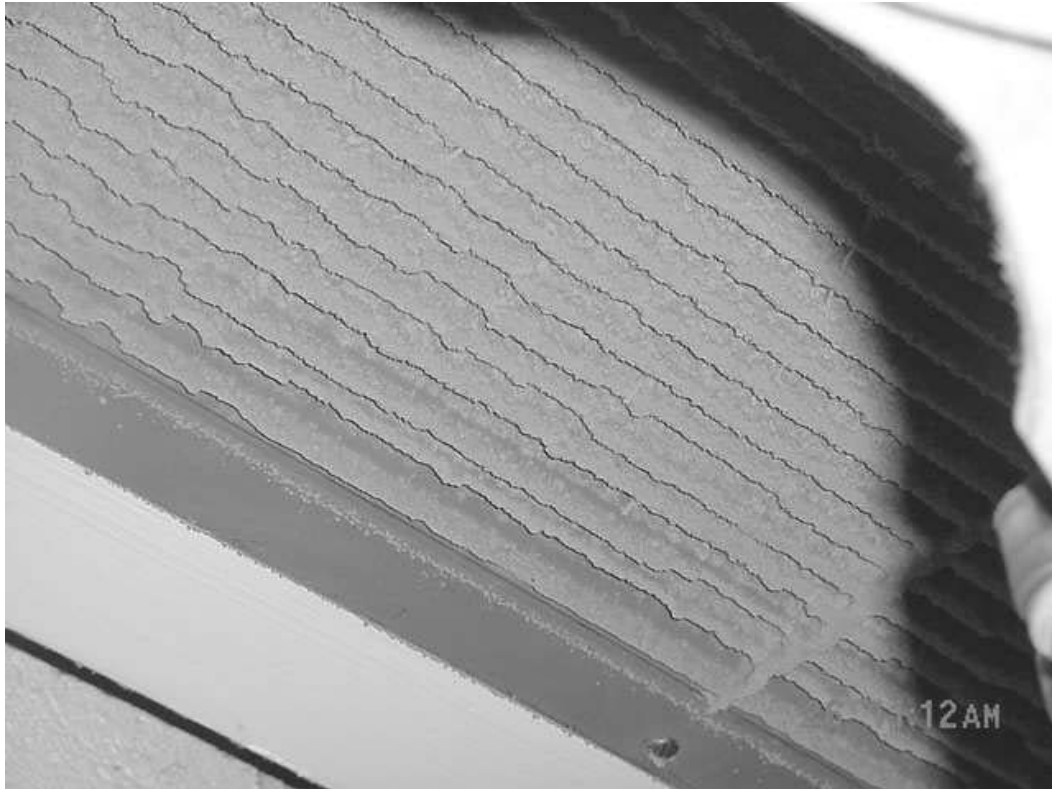
**Picture 9**

**Accumulated Dust on Closet Exhaust Vent**

11. Clean exhaust vents periodically of accumulated dust.
12. Relocate or consider reducing the amount of materials stored in classrooms to allow for more thorough cleaning. Clean items regularly with a wet cloth or sponge to prevent excessive dust build-up.

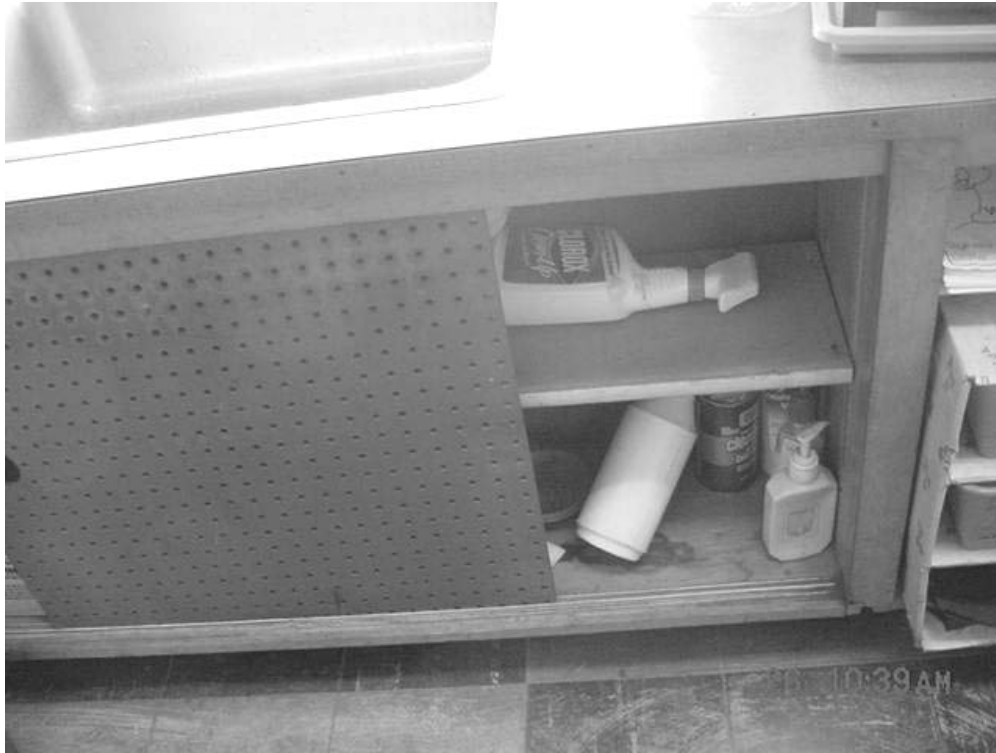
**Picture 10**

Cleaning products and unlabeled containers were found on countertops and beneath sinks in a number of classrooms (Picture 10). Cleaning products contain chemicals, which can be irritating to the eyes, nose and throat and should be stored properly and kept out of reach of students. In addition, bottles should be properly labeled in the case of an emergency.

**Spray Cleaning Products and Unlabeled Materials Under Sink in Classroom**

13. Store cleaning products properly and out of reach of students. Ensure spray bottles are properly labeled in the event of an emergency.
14. Consider discontinuing the use of tennis balls on chairs to prevent latex dust generation.

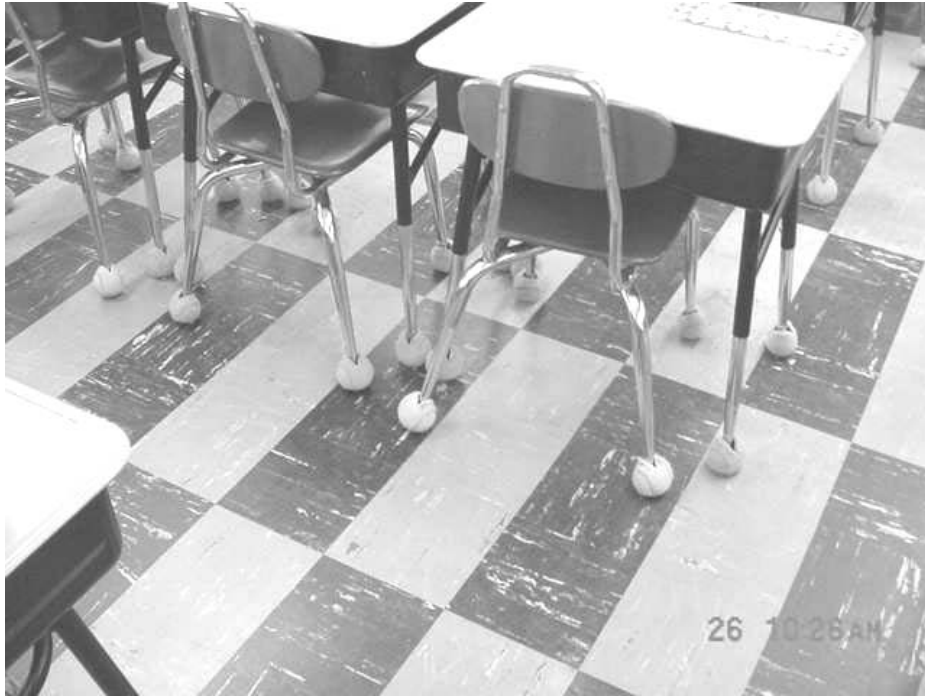
**Picture 11**

In an effort to reduce noise from sliding chairs, tennis balls had been sliced open and placed on chair legs (Picture 11). Tennis balls are made of a number of materials that are a source of respiratory irritants. Constant wearing of tennis balls can produce fibers and allow VOCs to off-gas. Tennis balls are made with a natural rubber latex bladder, which becomes abraded when used as a chair leg pad. Use of tennis balls in this manner may introduce latex dust into the school environment. Some individuals are highly allergic to latex (e.g., spina bifida patients) (SBAA, 2001). It is recommended that the use of materials containing latex be limited in buildings to reduce the likelihood of symptoms in sensitive individuals (NIOSH, 1997). A question and answer sheet concerning latex allergy is attached as [Appendix B](#) (NIOSH, 1998).

**Tennis Balls on Bottoms on Chairs and Desks**

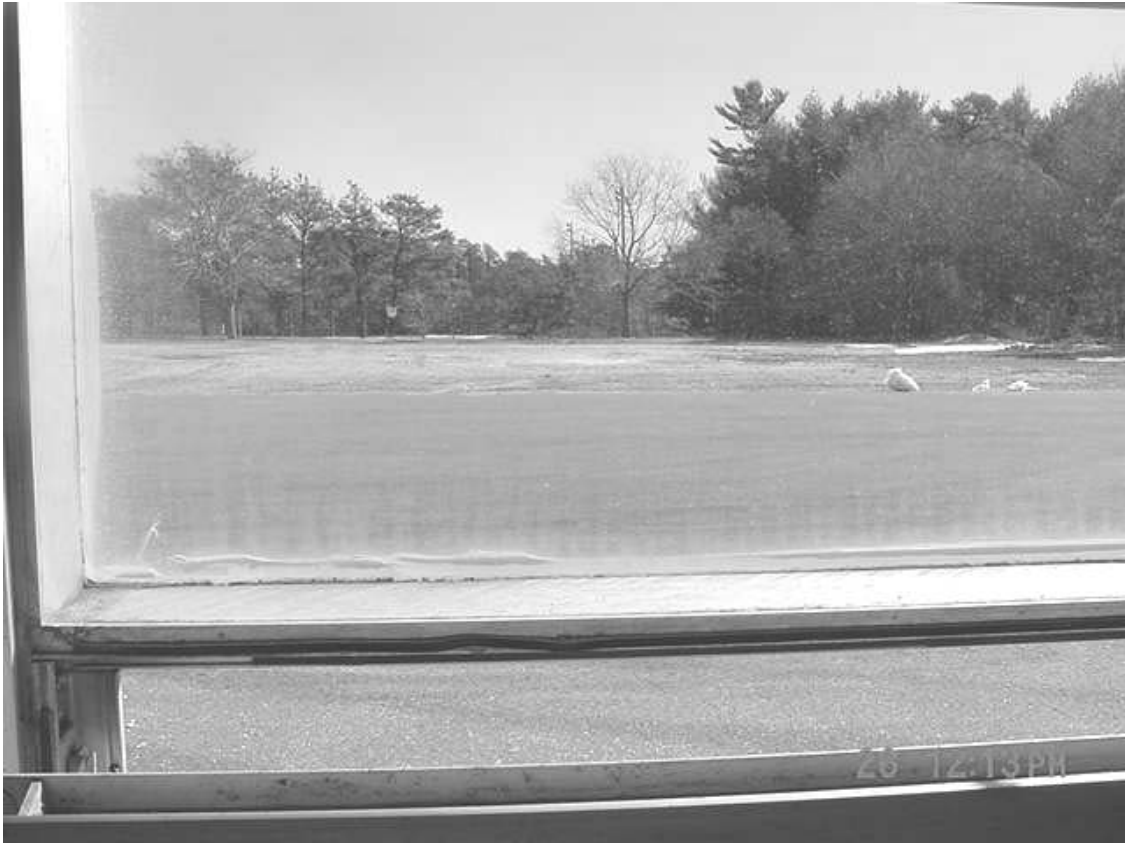
**Picture 12**

Finally, several occupants had concerns of dirt and dust infiltration from road dirt that is reportedly deposited behind the annex building twice a year (Picture 12). Depending on wind and weather conditions this activity can generate airborne dust and debris that can be drawn into univents operating on this side of the building or through open classroom windows.

**Lot Area Where Road Dirt is Reportedly Emptied, Picture Taken From Inside Classroom**

15. Coordinate with Town and School officials to schedule delivery of dirt during non-occupied periods. If not feasible, notification should be made prior to delivery to ensure

airborne dirt and dust are not entrained into the building. This may entail temporarily deactivating univents and closing of classroom windows.
